ROOFLINES

FALL 2000

Residence of the Netherlands Ambassador

International Team Renovates Embassy Row Landmark

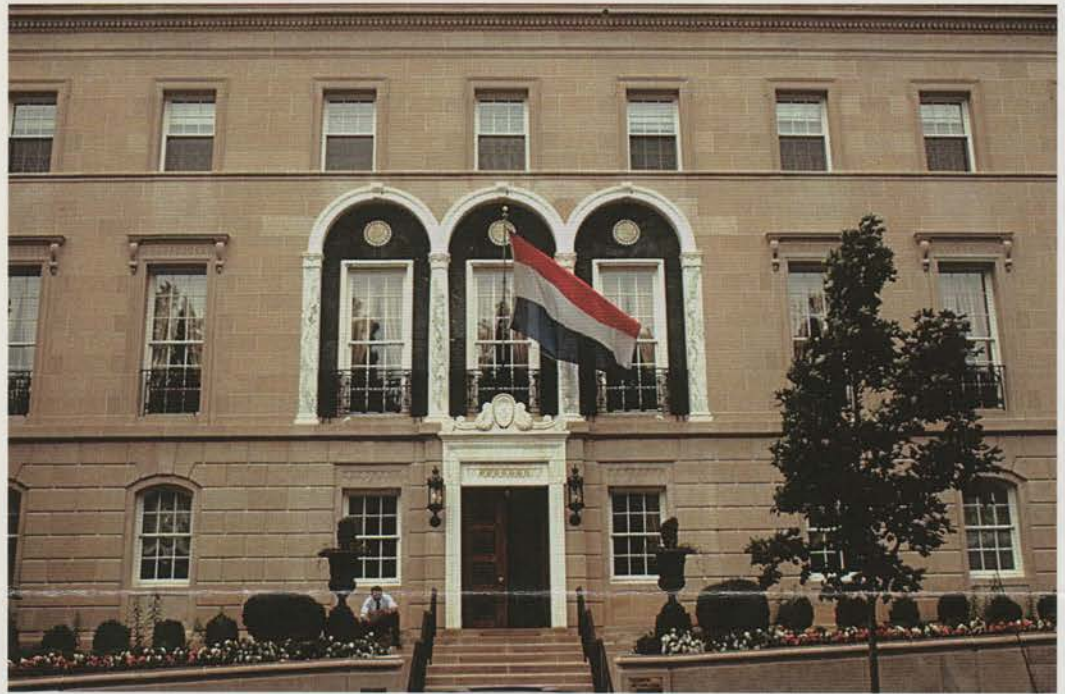
This neoclassical-revival mansion owned by the Netherlands is both the ambassador's home and a private museum. Renovating the mansion's exterior and interior was a complex five-year international project. Wagner replaced all roofing above the gutter line.

Wagner was asked to replace “everything above the gutter line,” says Merkezas. The relatively new zinc-lined gutters appeared to be the one area of the roof system that could be salvaged. Plus, Merkezas adds with a smile, “the Dutch workmanship is impressive.” To protect the gutters, Wagner workers needed to take extra precautions while working in those areas,

The original metal that covered the flat roof had been replaced earlier with asphalt. To meet the client’s performance criteria, including low maintenance and long life, Wagner removed the asphalt and laid a soldered-seam stainless steel roof. Visiting Dutch architects and consultants frequently climbed to the roof to watch Wagner workers install the mirror-like stainless steel pans—not only to monitor the project, but also to learn about an unfamiliar technology.
