ROOFLINES

SPRING 2012

Discovery in Tudor Place's Temple Portico Dates Historic Roof

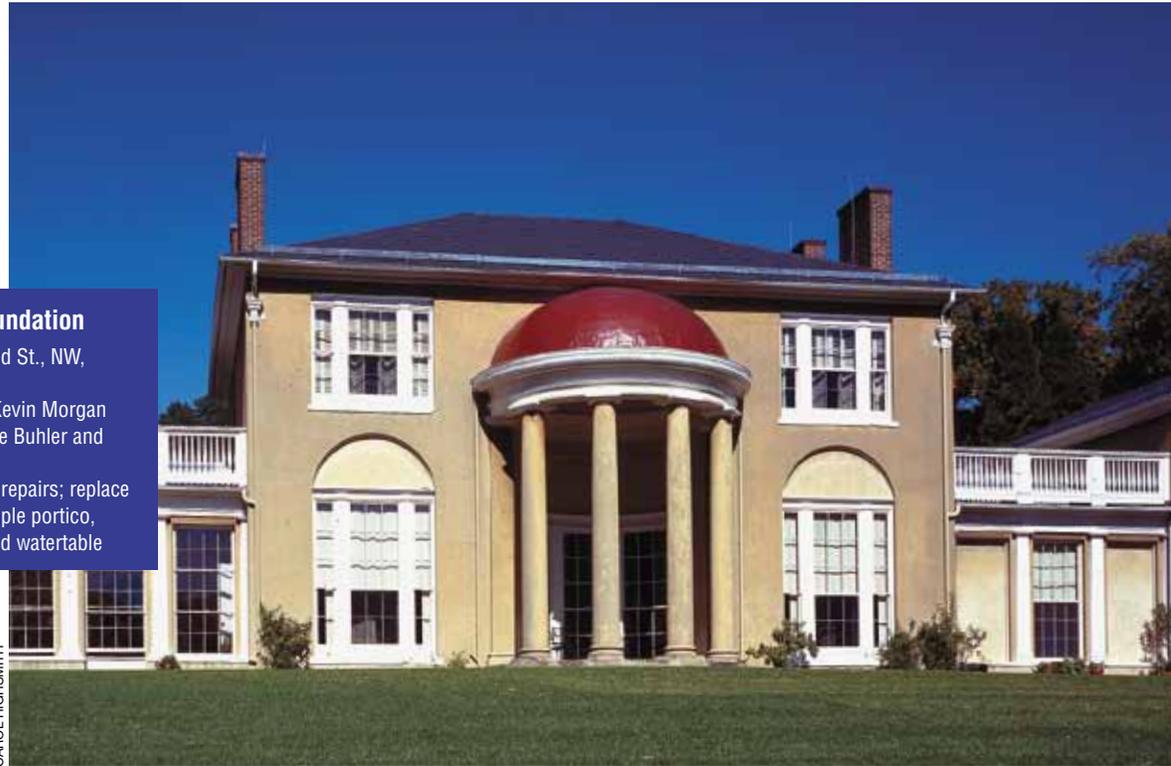
Tudor Place Foundation

Roofing: Structural repairs; replace metal roof on temple portico, built-in gutters and watertable

When Elizabeth Peebles, preservation manager at Georgetown's Tudor Place Historic House & Garden, took a close look at some nails from the building's portico in January, she was elated. After all, the old nails—which had been uncovered as Wagner Roofing prepared to replace the semi-domed roof on the south façade's Temple Portico—told Peebles something about the history of the building.

“When Bob [Wooldridge] and his guys took off the top portion of the metal roof, they found a lot of the original wood sheathing,” Peebles says. “It had evidence of nail holes that suggests it was once a wood shingle roof.” She said the nails had cut shanks and double-struck wrought heads—an earlier nail that she dates to about 1816. This part of the

After opening more of the roof and having the nail patterns reviewed by expert architectural historians, it is presumed that the roof never had wood shakes, but a previous metal roof with smaller pans. The roof has since been

at the gutter line. Furthermore, the metal roof itself had been on its last legs, heavily rusted and worn. The only previous work to the roof in the last century had been limited to minor repairs and multiple layers of paint. The first tin roof lasted 68 years, and the second survived 140 years.

Chuck Wagner says the new lead-coated copper roof, installed by Randy Herald, will last more than 200 years. "The biggest challenge on this job was the radiused work required on the built-in gutter and watertable, which had to be installed in 18-inch sections," he says. "Then every seam had to be soldered. The new roof seams had to match the existing pattern down to the 1/8 inch."

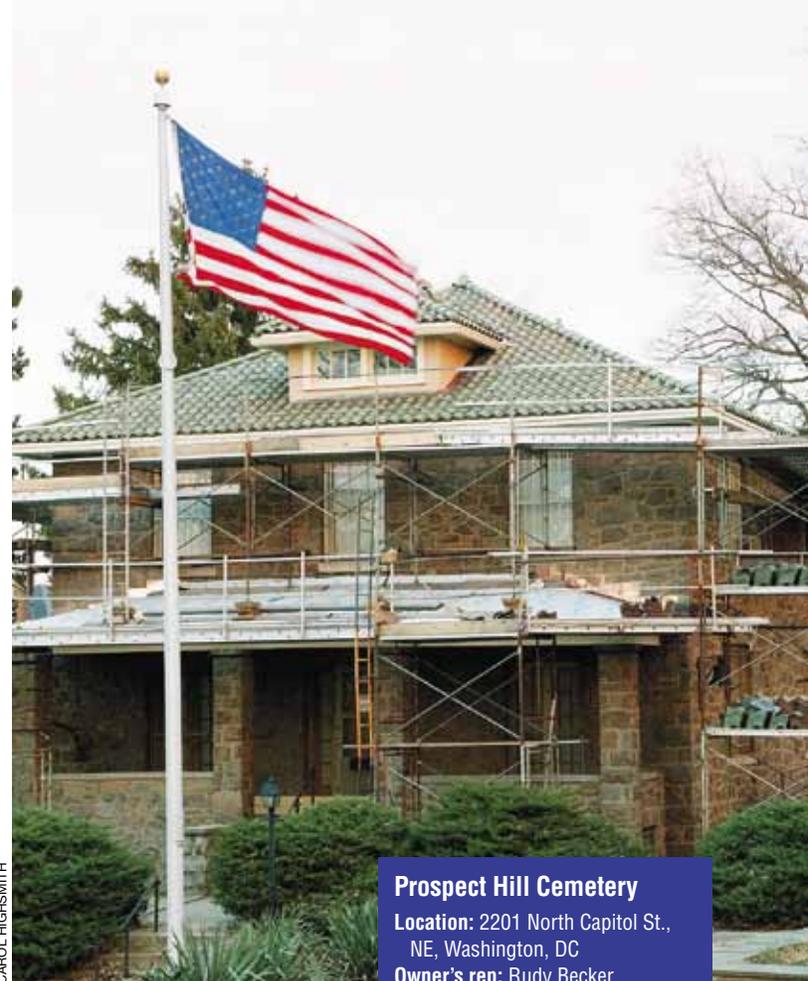
Prospect Hill Cemetery

Built in 1927, for a cemetery that was established in 1858, the stone house was showing its age: The woodwork at the eaves had deteriorated, and the gutters were rusted and underperforming. Wagner removed all the gutters and tiles. The two-month project also included all new copper flashings, new aluminum gutters and downspouts, new tongue and groove soffits, and fresh paint on the soffits, fascias, windows and doors.

Roofing: Replace tile roof, gutters and downspouts, carpentry, paint soffit and fascia

remain clay. Wagner removed all the old tiles, saved those that were in good condition and replaced the others with salvaged, weathered tiles. The old tiles were tested by the original manufacturer—Chicago's Ludowici Roof Tile—to make sure they were strong enough to withstand snow, ice and the weight of maintenance workers.

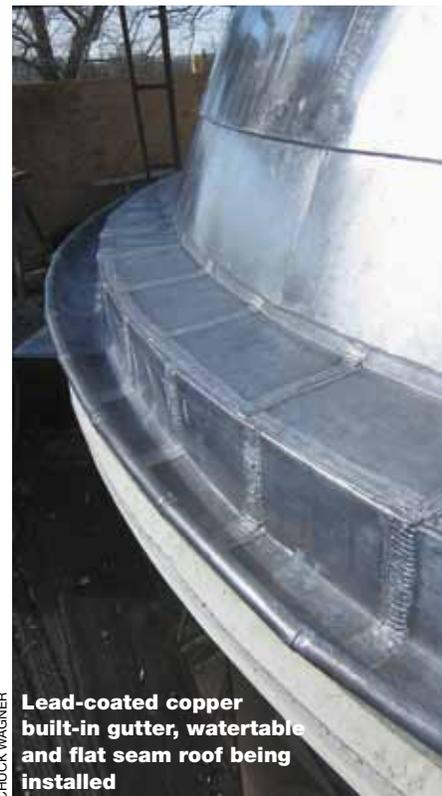
Lead-coated copper built-in gutter, watertable and flat seam roof being installed

at Tudor Place after working as an architectural historian for the National Park Service, documented every part of the structure. She was especially interested in the interior sheathing—now largely deteriorated—that Wagner covered and preserved with two layers of quarter-inch plywood. She took photos, measurements and notes. In addition to documentation, the laser scans can serve as a future interpretive tool to create 3D models and illustrations of the early form of the historic house.

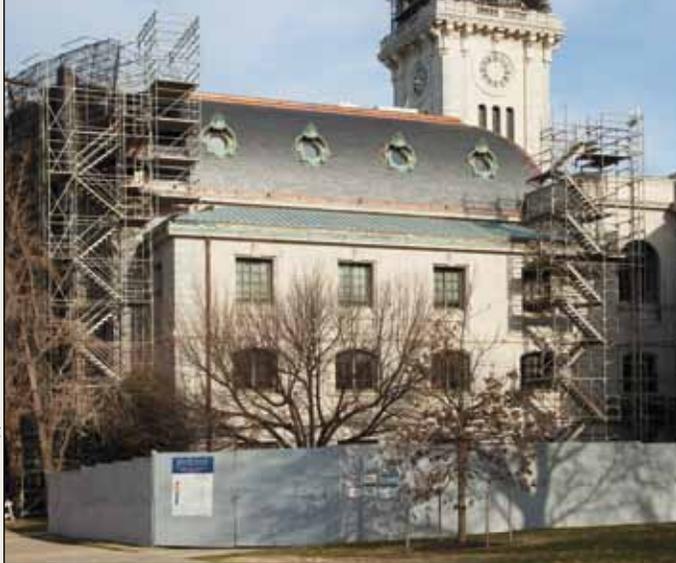
US Naval Academy Mahan Hall

Roofing: Slate and membrane roofs, built-in gutter, clean historic skylights, restoring copper dormers

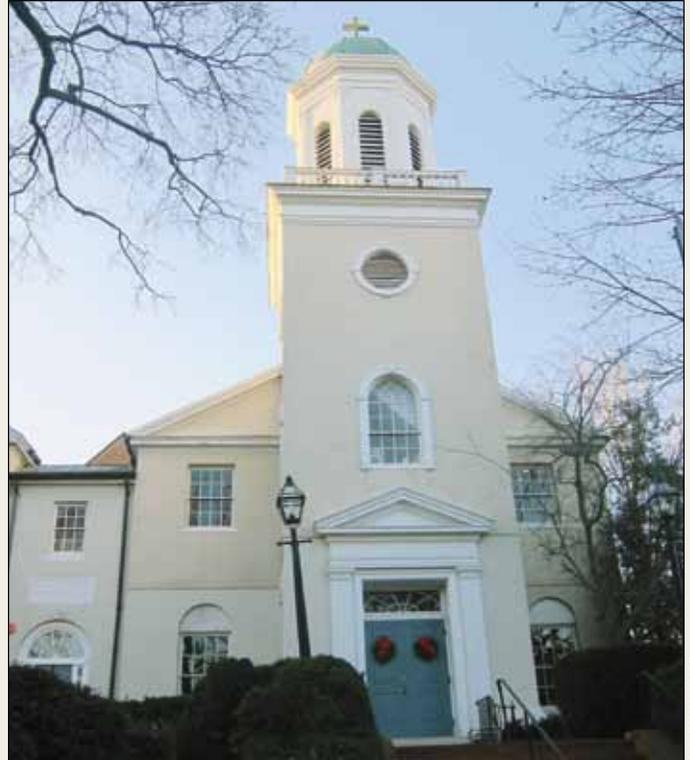
Saint John's Episcopal Church

Roofing: Replacing built-in lead-coated copper gutters, 90 mil rubber, slate, removing and closing over skylights and reproducing existing decorative finial.

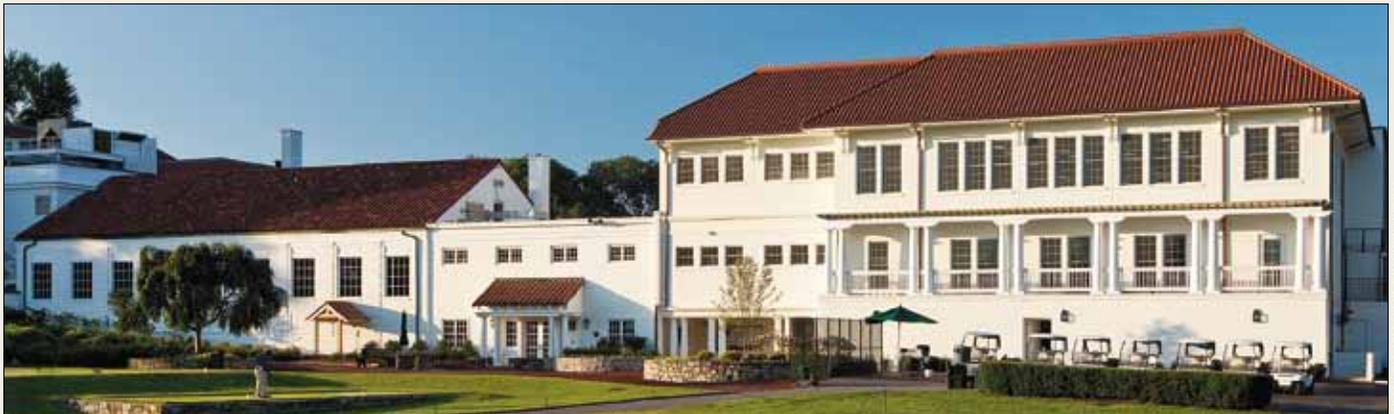
Columbia Country Club

Roofing: Replacing TPO roofing on ballroom, dining room, and gold room

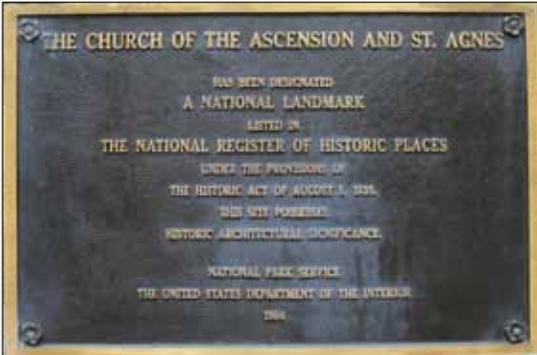
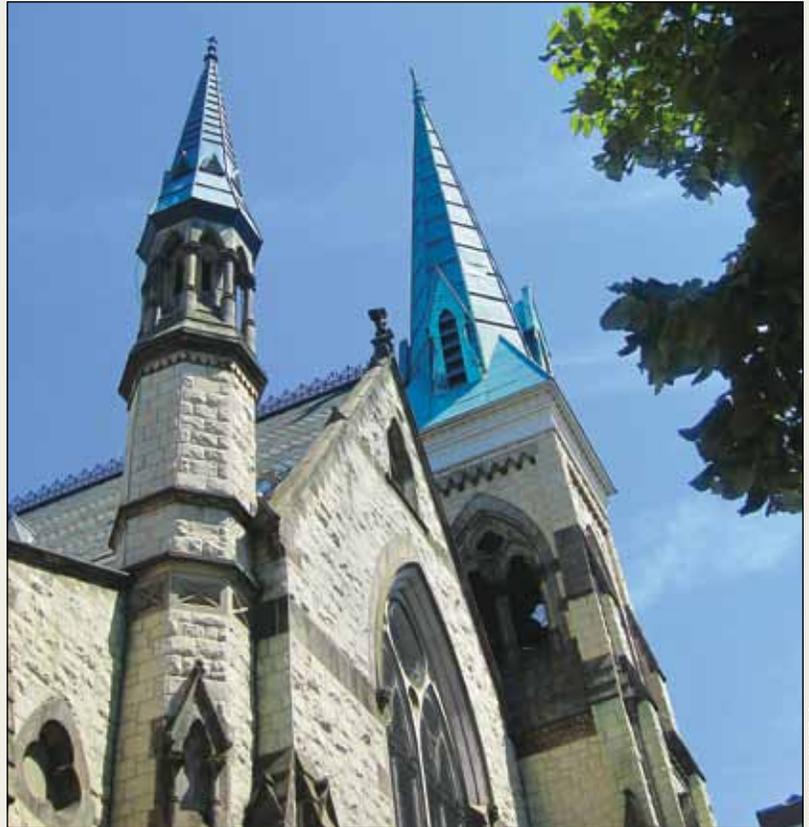
Church of the Ascension and St. Agnes

Roofing: Structural repairs at steeple due to earthquake damage. Replacing seven stone columns and hand-carving new capitals, the uppermost part of the column.

We then put scaffolding up around the 70-foot-high, eight-sided steeple and stabilized the structure. The same engineers who designed the National Cathedral earthquake repair strategy used similar methods at the church. We wrapped the steeple in steel to stabilize the falling arched sandstone and structural wood beams. Now

that we have a permit, we will remove the copper roofing at the eave to replace structural beams and carved sandstone.

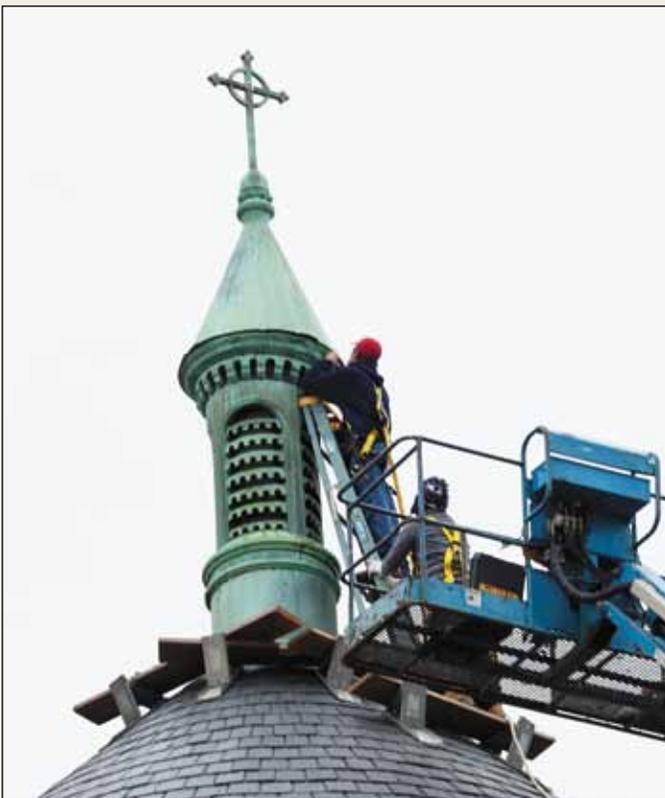
Catholic University Caldwell Hall

Roofing: Restored copper finial being installed

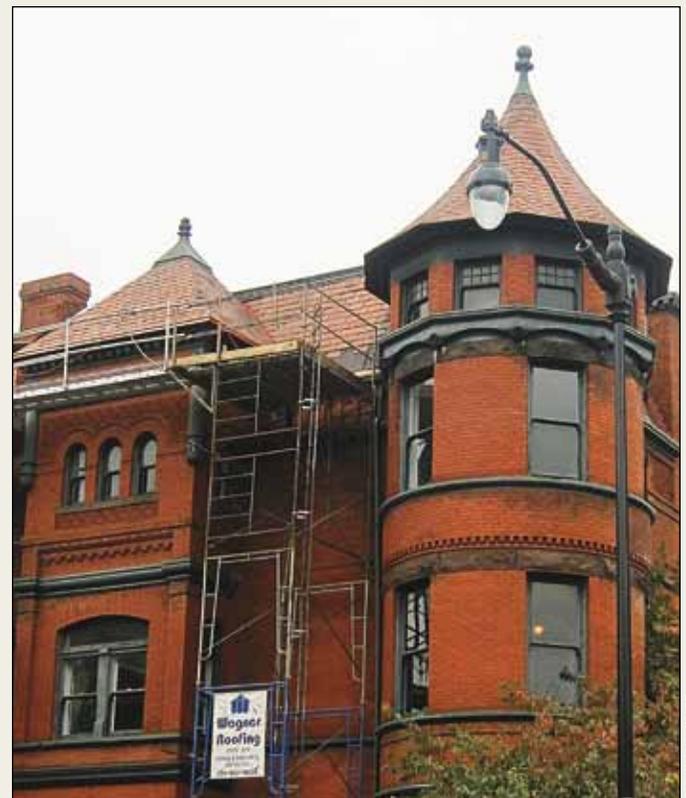
John Perazich

Roofing: Installing new built-in copper gutter and repairs to Vermont slate roof
